Impact and vibration transmission measurements of Masonite Beams AB test house.

RISE Report: 2022:113

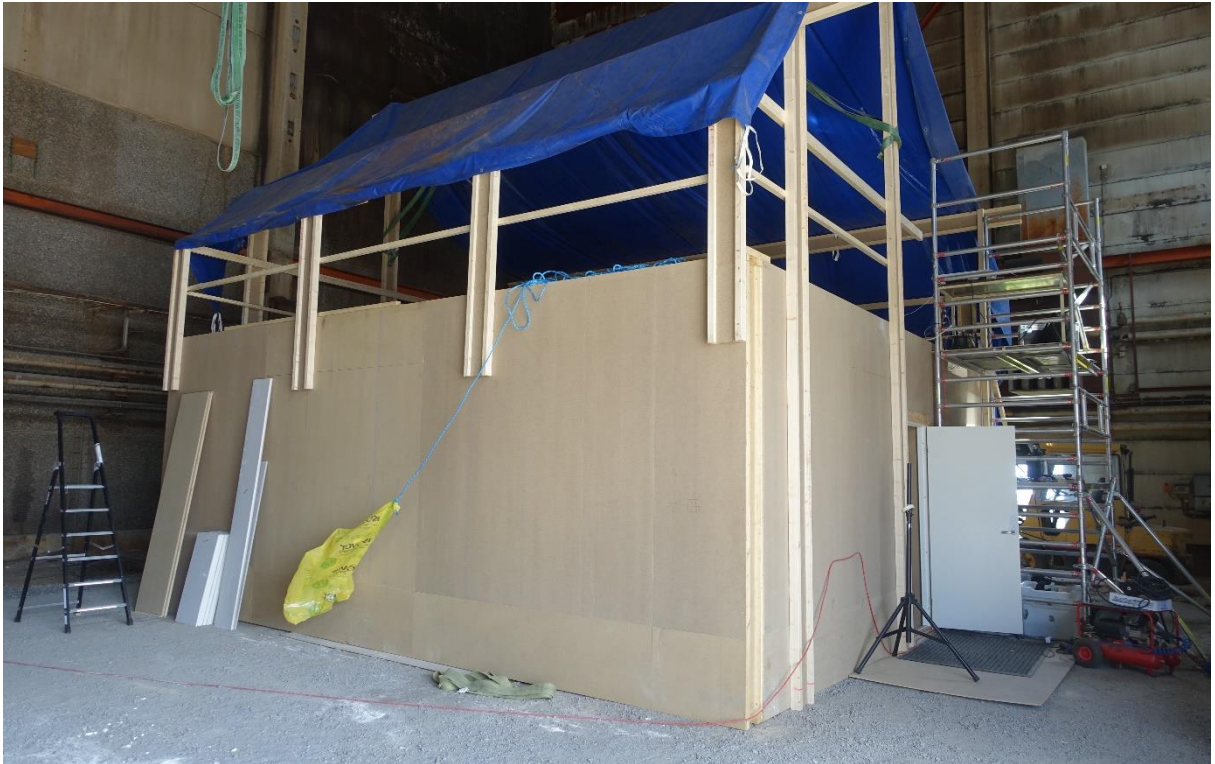
Figure 5. The test houses at the measurements with the scaffolding as a platform for the measurement system. The test house walls are standing on gravel. The test house is located within a large industrial building at Masonite Beams in Rundvik. The scaffolding is not connected with the test house structure.

The measurements on the structural test house were made at Masonite Beams AB in Rundvik, Sweden. The test house, the preparations and the ideas of the setups tested is made by Tommy Persson and Alfred Wikner at Masonite Beams AB. The test house consists of the main parts, important for impact sound transmission. Full scale walls and floor structures for having realistic transmission of direct sound transmission and flanking transmission via connections and then to radiating connected surfaces. The conceptual design and dimensions are shown in Figure 2 and Figure 4. The exterior of the test house during the trials are seen Figure 5. The interior at the measurements with all the sensors mounted is seen in Figure 6.

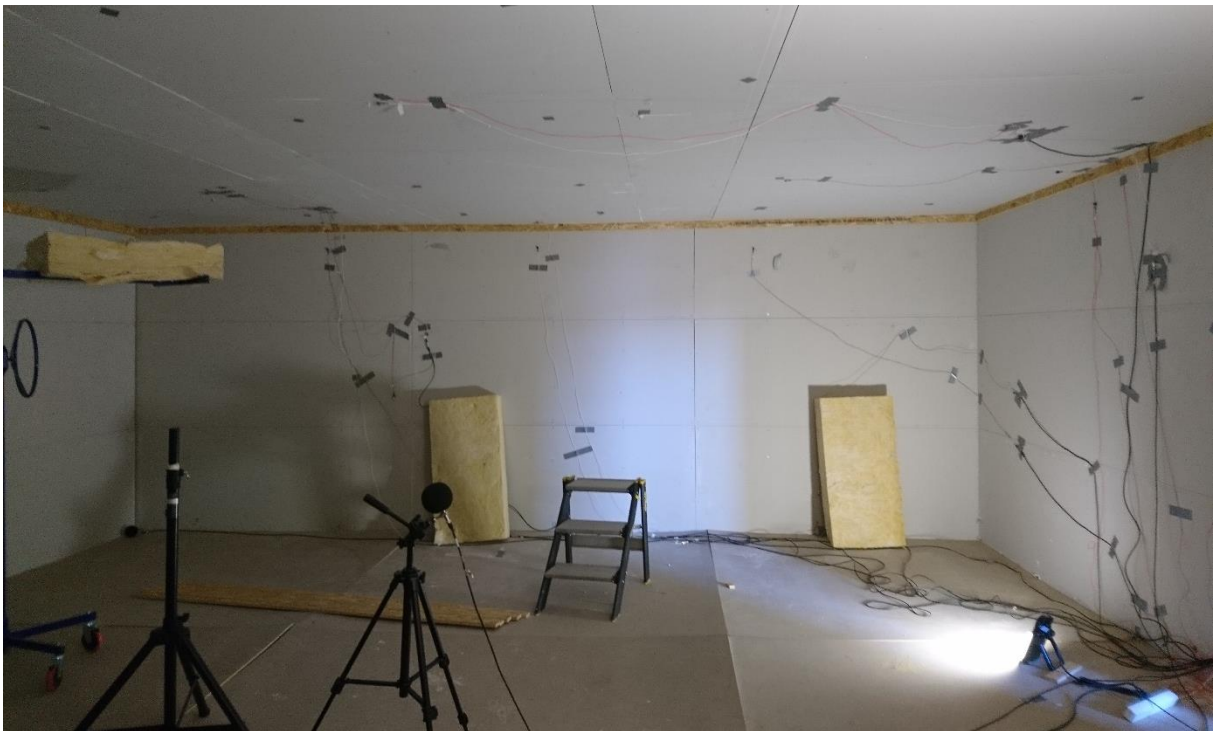
Figure 6. The measured, receiving room below (here at the gable wall direction, at the last measurement setup number 8).

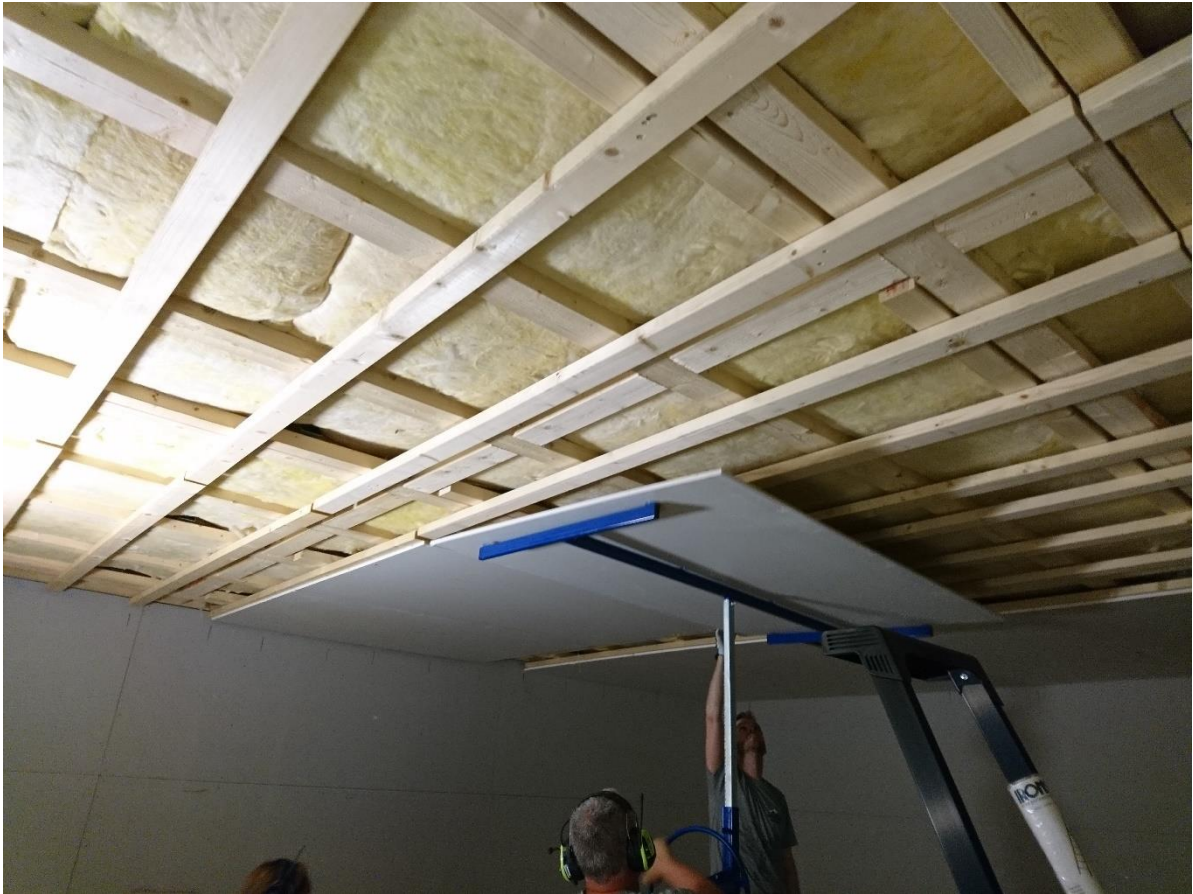
Figure 7. Mounting of the first layers of gypsum boards, test setup version 1. The laths which the gypsum boards are fastened to are suspended (you may note a small distance between the laths and the structural beams above).

The major changes in the test setup are shown in the Figure 7 to Figure 13 below.

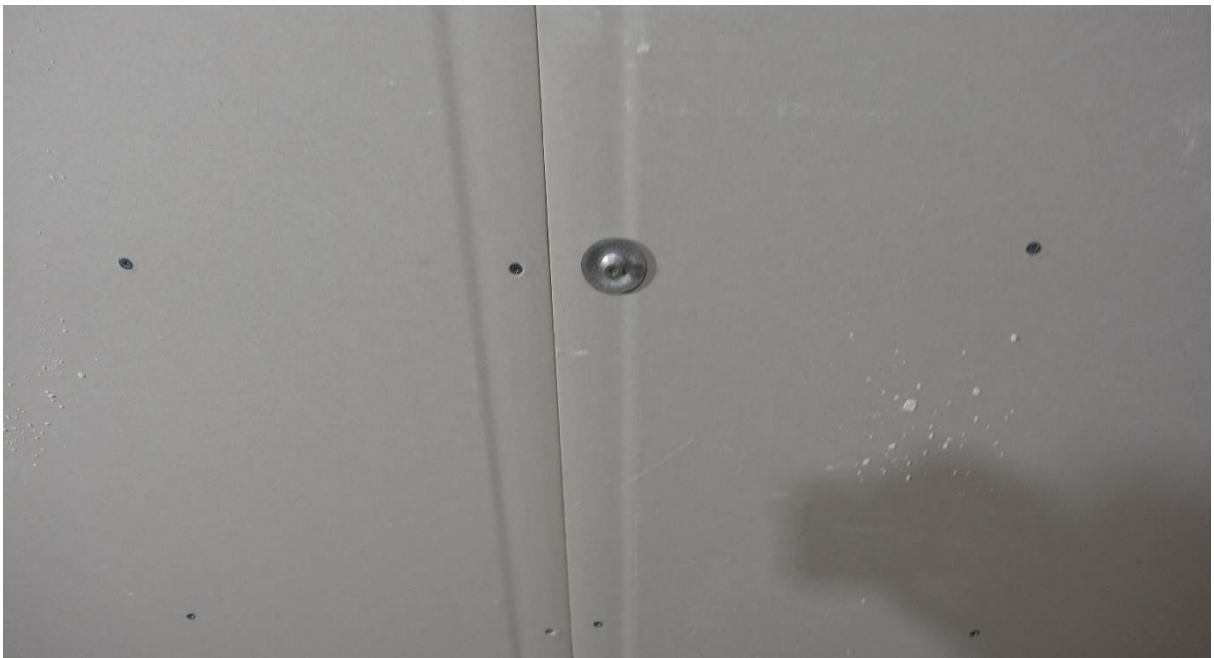
Figure 8. Test setup version 2, fastening the gypsum boards against the ceiling joists with screws and washer to take away the suspended ceiling effect.

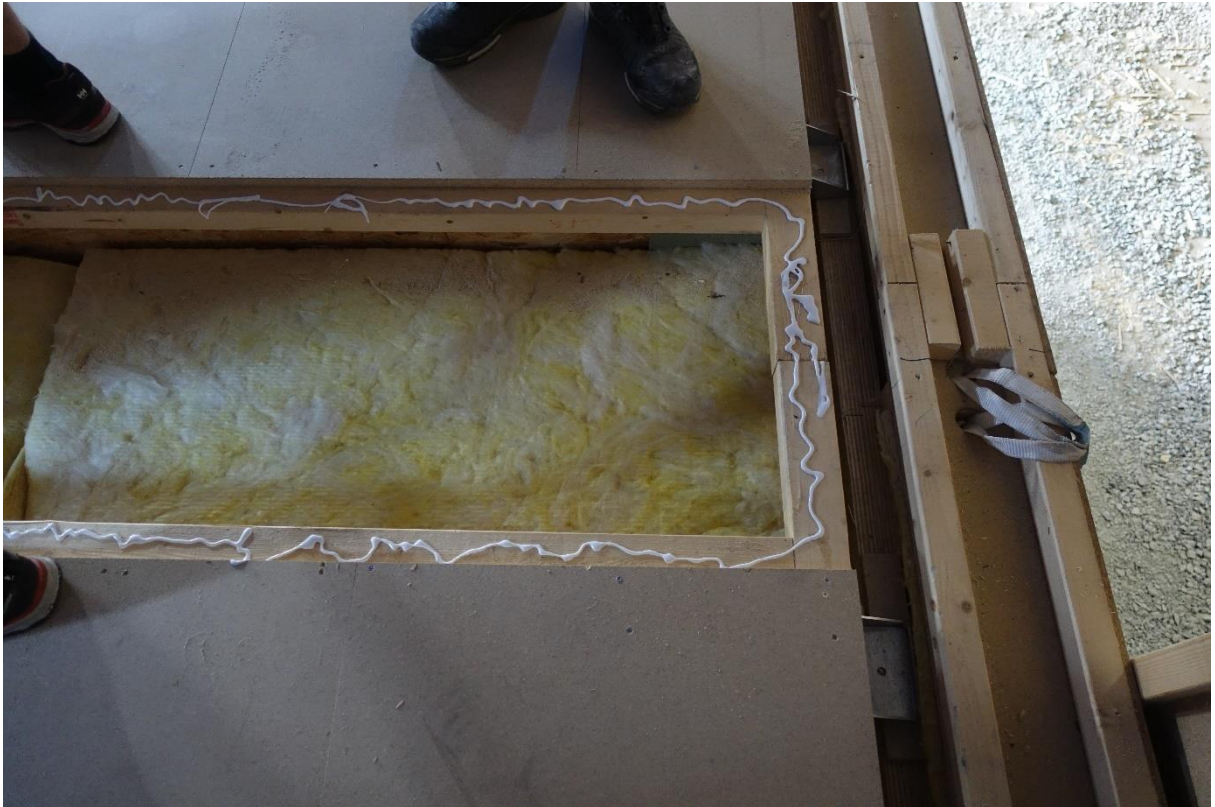
Figure 9. Test setup version 3, gluing and screwing of the particleboards to the joist in the floor.

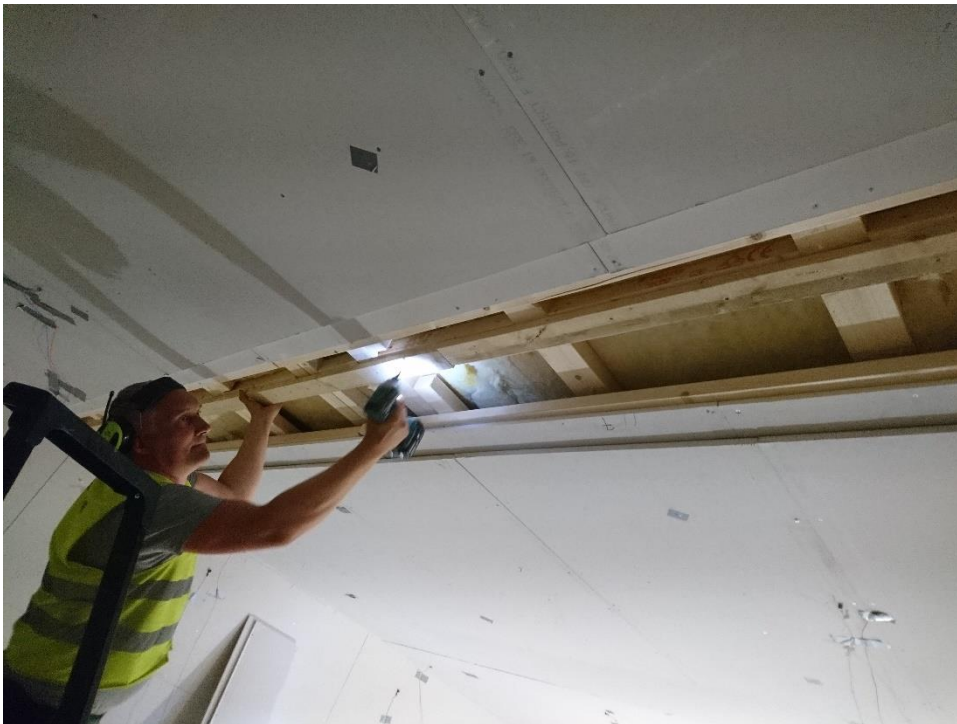
Figure 10. Test setup version 5, Screwed and glued lath to create composite action of nogging rows. Second gypsum layers added before measurements.

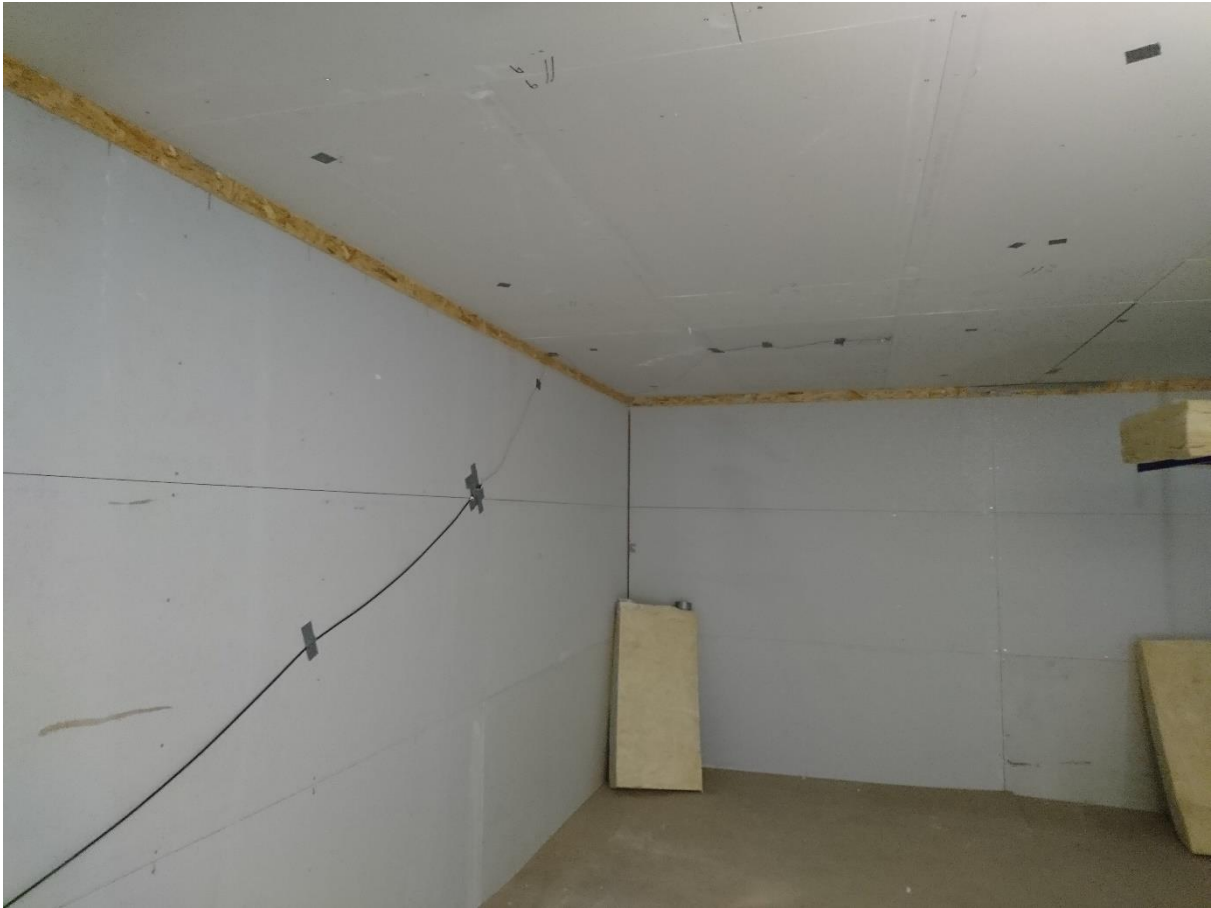
Figure 13. Test setup version 8, OSB strips fastened in the corners to represent the use of cornices.

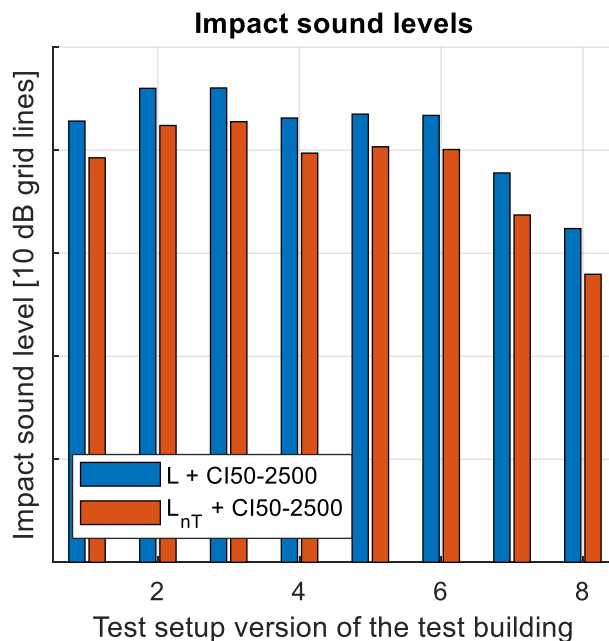
Figure 14. Measured, relative, averaged impact sound level before reverberation correction and standardized impact sound level (reverberation time corrected).

In Figure 14 is the single values for impact sound insulation according to Swedish regulation SS 25267, presented. The measures that affect the weighted single values are first the suspended ceiling with about 3-4 dB. The suspended ceiling is activated in setup 2 and disabled in setup 4, which clearly affects the results. It is seen that the added layer of gypsum (setup 7) and the cornices (setup 8) is what really improve these weighted single values.

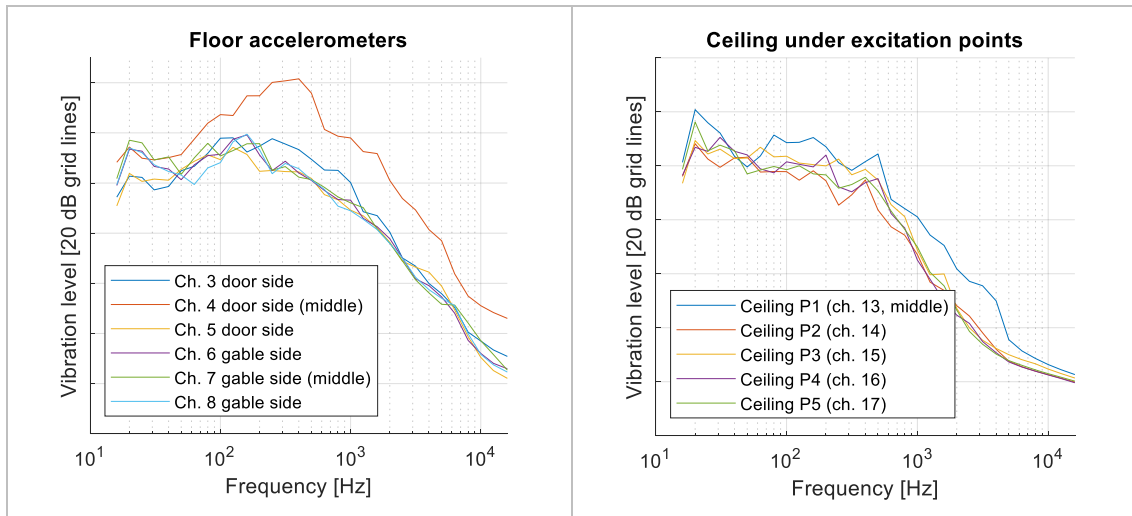
Figure 15. The results of all the accelerometers for one impact point, here in the middle of the floor (P1, in Figure 2), test setup 1. Left diagram shows the accelerometers on the floor. The right diagram shows the accelerometers at the different points at the ceiling in the room below.

The measurements contain large amount of data. The data is visualized in different categories of spectrums to help understand the results. First, all accelerometers for one measurement are plotted. This is done in Figure 15 and Figure 16 for the first excitation with the tapping machine in the middle of the floor, for test setup 1. It is seen that (see Figure 2 for reference to channels and excitation points) the highest levels occur at the channel 4 sensor in the middle along the door side, at the area where the joist floor is supported. For the accelerometers on the ceiling, it is seen that the accelerometer in the middle, directly under the where the tapping machine is in this measurement, by a small margin have the highest levels of these accelerometers. For the ceiling 0.2 m from the walls (Figure 16) it is seen that middle on the door side have the highest vibration levels in general, at least above 100 Hz. For the walls 0.2 m from the ceiling (Figure 16) it is seen that middle on the door side as well have the highest vibration levels in general, at least above 100 Hz. The levels indicate that for the first setup the flanking transmission to the door side should be a significant transmission path. The results are logical in general, the highest levels are located closest to the excitation, directly under at the ceiling and at the door side in the middle where the floor is supported. It is clearly seen

that there is less vibration transmission perpendicular to the carrying direction of the floor.

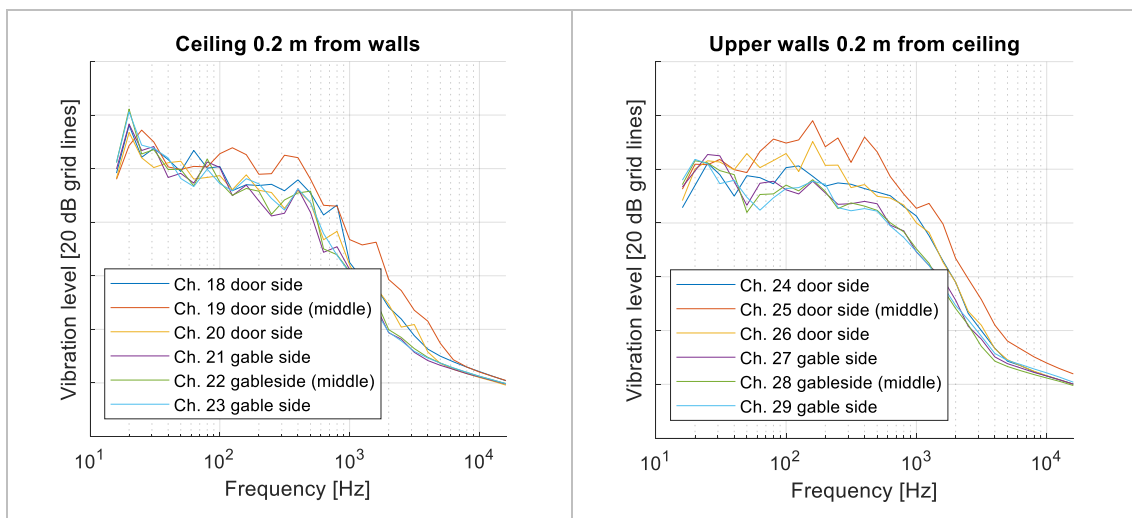
Figure 16. The results of all the accelerometers for one impact point, here for the floor (P1, in Figure 2), test setup 1. Left diagram shows the accelerometers on ceiling 0.2 from the wall, in the room below, and the right diagram shows correspondingly the accelerometers on ceiling 0.2 from the wall.

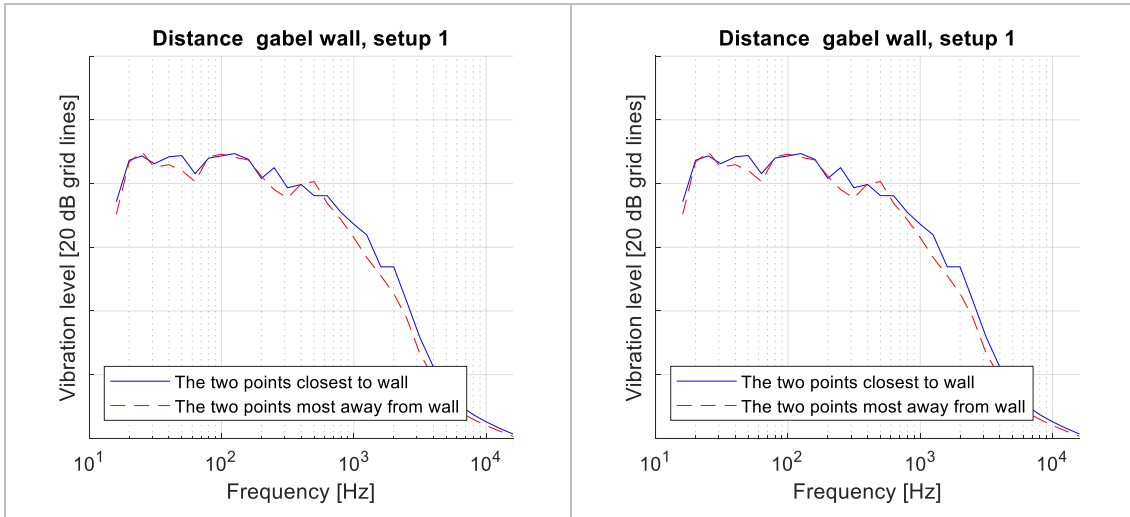
Figure 17. Results for Setup 1. In the left diagram, all the accelerometers located on the long side (door side) wall, 0.2 m from ceiling, averaged for all tapping machine impact points. The right diagram is showing the short side wall, 0.2 m from ceiling (right side when standing at the door looking in).

In Figure 17 it is seen the difference when the tapping machine is located on the two out of five points nearest the wall where the accelerometers are located, compared to when the two points located most far away from the measured sides. It is seen that there is a larger difference on the door side. That is on the sides where the floor is most structurally supported.

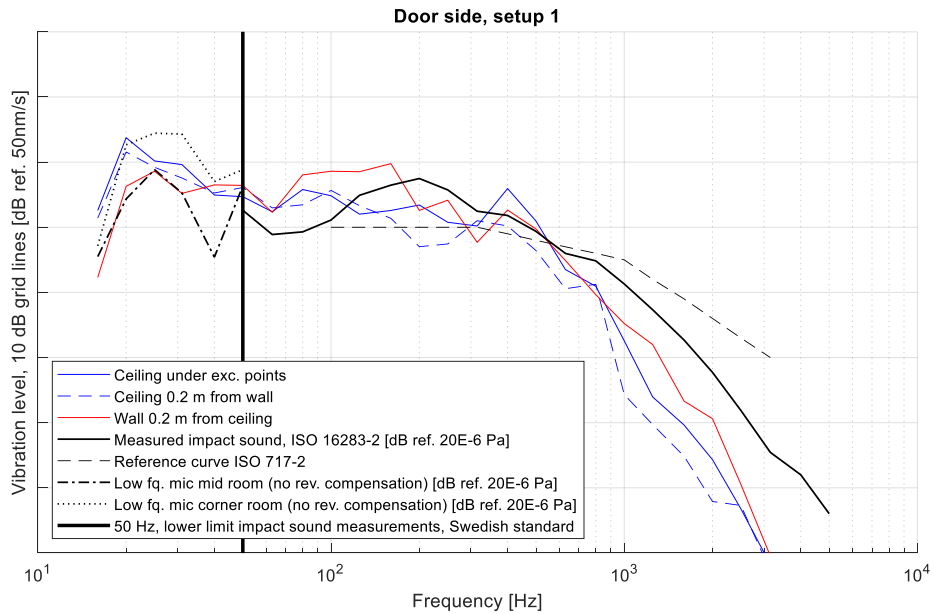
Figure 18. Measured impact sound levels presented with measured averaged vibration levels for the different locations, with the tapping machine. Here data is for the door side of the test building and for test setup 1.

The energy averaged vibration data and the impact sound levels of tapping machine measurements are presented together in the same diagrams from Figure 18 to Figure 25, for the door side (and the ceiling which is the same for both presented cases) and correspondingly from Figure 26 to Figure 33. The measured sound level and the vibration levels are in most cases around the same levels. One exception is when the suspended ceiling is disabled (setup 2 and setup 3). Then the ceiling vibrations is a bit higher, although the measured sound insulation also is increased. What can be seen is that the characteristics of the measured sound levels are in high degree similar in its spectral characteristics (Figure 19 and Figure 20 black solid line vs blue solid line). This makes it likely that the ceiling vibrations dominates the sound radiation. For the later setups there is lower levels, especially above 100 Hz. For the lowest frequencies presented down to 20 Hz, it is seen that there is less attenuation. However, this lowest range is not included sound classification regulations.

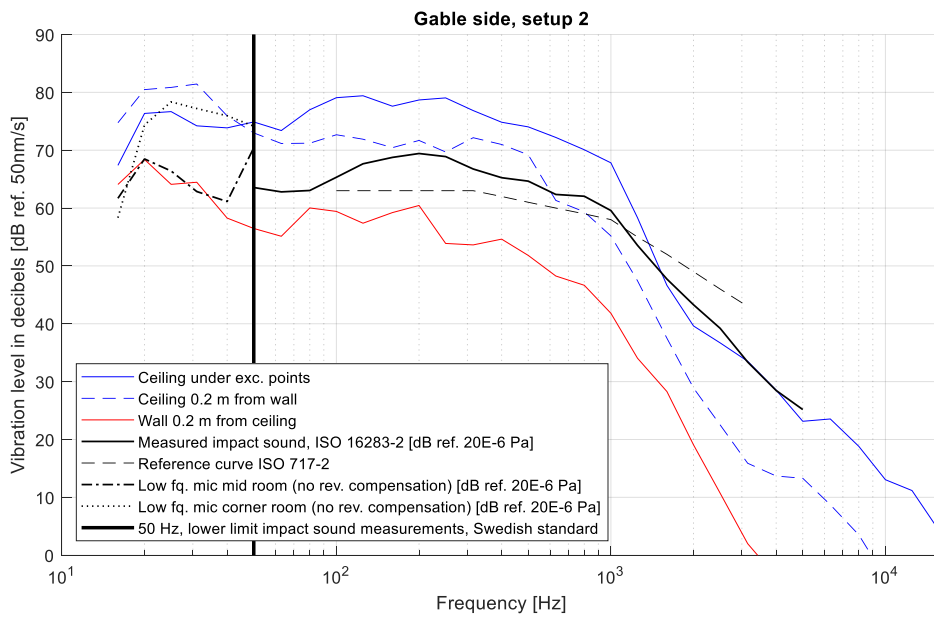
Figure 27. Measured impact sound levels presented with measured averaged vibration levels for the different locations, with the tapping machine. Here data is for the gable side of the test building and for test setup 2.

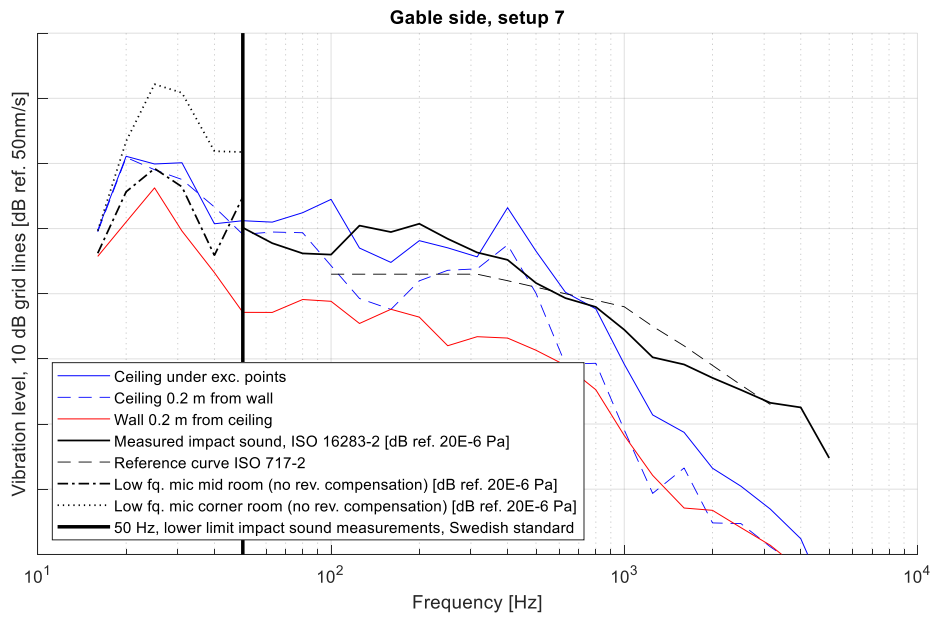
Figure 32. Measured impact sound levels presented with measured averaged vibration levels for the different locations, with the tapping machine. Here data is for the gable side of the test building and for test setup 7.

For setup 7 added gypsum layers are put on the floor, both ceiling and wall vibrations are decreasing. Looking on the character (spectra) of the vibrations, the wall characteristics looks more like the impact sound, even though the walls have lower sound vibration levels on the measured locations (Figure 32). However, the measured locations may not be the ones with the highest amplitude on the walls. The accelerometers are put 0.2 m from the edges and edges are rather stiff points. It can not be ruled out that vibration levels are higher further from edges, i.e., lower on the walls. For the last setup 8, there is no measured vibration level decreasing and yet it has the lowest impact sound levels. It may indicate that the improvement for the last one is due to leakage is taken away (since there was a small gap between wall and ceiling until setup 8, cornices were added).

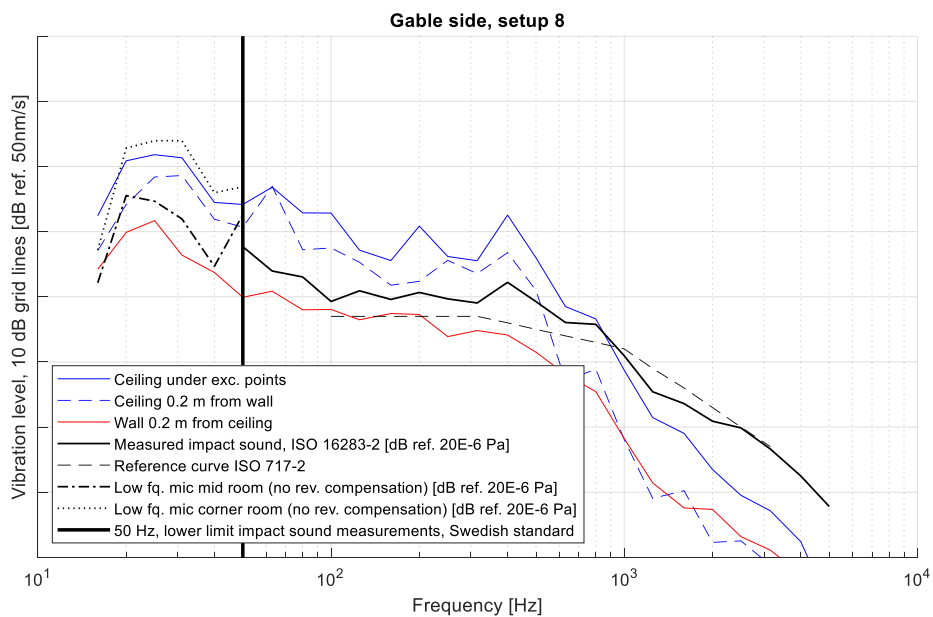
Figure 33. Measured impact sound levels presented with measured averaged vibration levels for the different locations, with the tapping machine. Here data is for the gable side of the test building and for test setup 8.

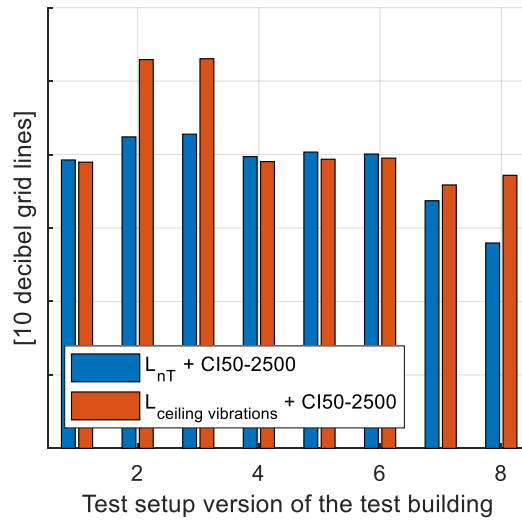
Figure 34. Diagram showing measured impact sound levels according to Swedish regulation, and the same when the averaged ceiling vibrations (dB ref. 50 nm/s) under the ceiling are weighted in the same way.

The weighing method used for calculation of the regulatory sound pressure level $L'_{nT} + C_{I, 50-2500}$, may also be used for the vibration levels. This makes it easier to relate the characters and levels of different vibration location categories to the measured impact sound levels. In Figure 34 to Figure 36 the measured impact sound levels are presented with each of the different energy averaged accelerometers locations, weighted in the

same way. It could be seen that there is in general a similar pattern between the measured sound levels and the measured vibration levels, however it is not perfect. It seems likely that the dominating sound transmission, i.e., direct transmission and flanking transmission differs through the different setups.
